Logan Dam Site

Dam Site Geology

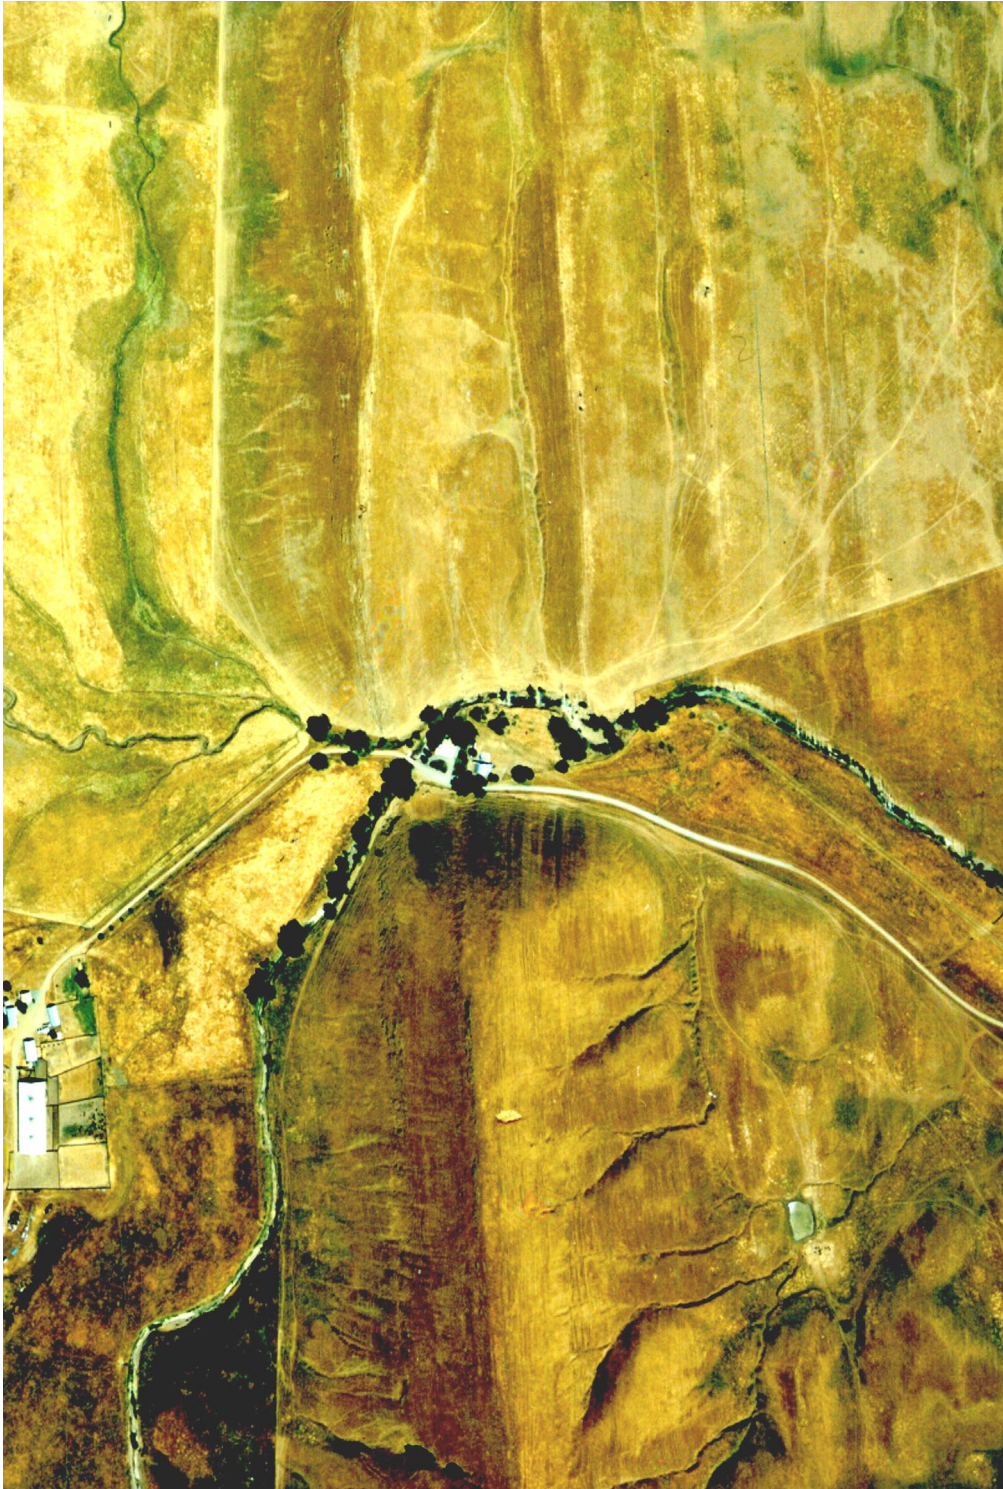
Photo 38. Aerial view of Logan water gap at Logan Dam site

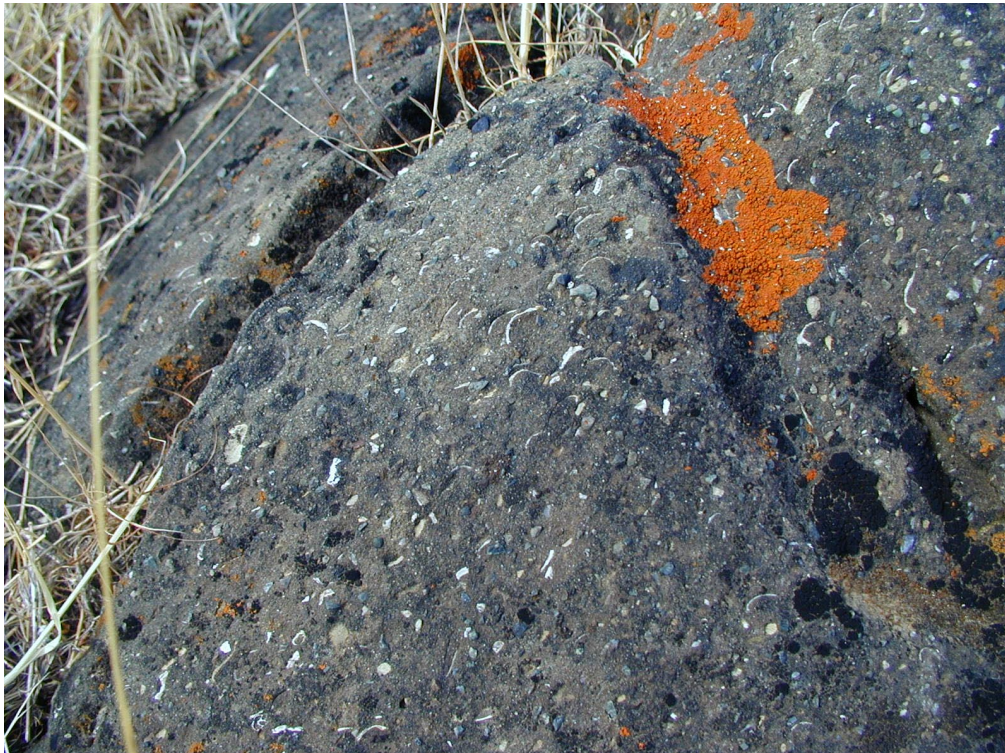
Fresh sandstone is light to medium olive gray in color and yellowish brown where weathered. It is mostly a very fine to medium-grained well-sorted arkosic sandstone with a silty to clayey matrix. Bedding is massive to cross-bedded and outcrops in units ranging from less than a foot to tens of feet in thickness. It contains thin interbeds of siltstone and mudstone that range from laminar up to 5 feet in thickness. It is typically weathered at the surface. It is moderately to well indurated, moderately to slightly fractured, moderately hard to very hard and strong. Internal structure is well developed in the areas of cross bedding and vague where massive. Calcite healing along fractures is common, with some pyritization. The unit contains discontinuous beds of well-rounded coarse pebble conglomerates up to 5 feet in thickness and within 50 feet of the Boxer–Cortina contact. A thin fossiliferous bed occurs in the basal sandstone unit approximately 80 feet above the Boxer–Cortina contact. The fossil bed is 1- to 3-feet thick, and the fossils are composed predominantly of pelecypod shell fragments. The fossil bed matrix often grades to a fine pebble conglomerate, indicating a high-energy depositional environment (Photo 39).

Photo 39. Fossiliferous sandstone and conglomerate at Logan Dam site

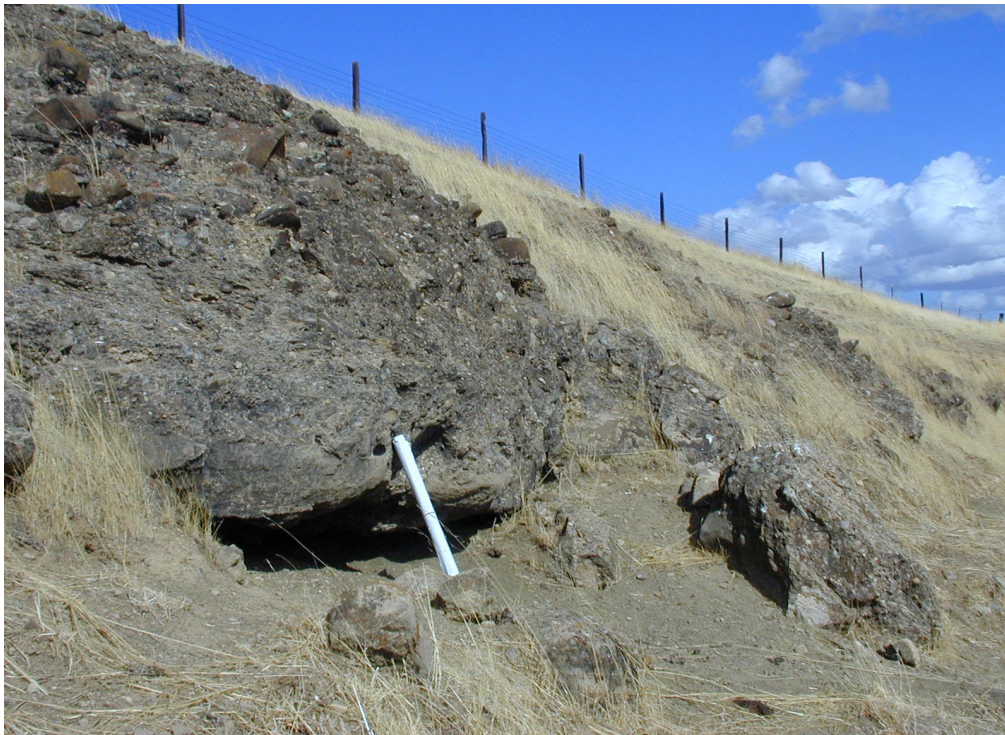
Five small landslides have been mapped at or near the proposed dam axis. Three of them occur on the north-facing slope of the right abutment, and the other two occur on the moderately steep west-facing slope of the left abutment in the Boxer Formation. All five landslides are small earth flows or debris slides with thicknesses of 2 to 5 feet and should not affect the proposed dam foundation. The Red Bluff Formation occurs at the northern edge of the map outside of the dam footprint (Photos 40 and 41). The formation consists of medium to coarse gravels with abundant sand, silt and clay.

Photo 40. Tertiary Red Bluff Formation overlying Cretaceous Boxer Formation

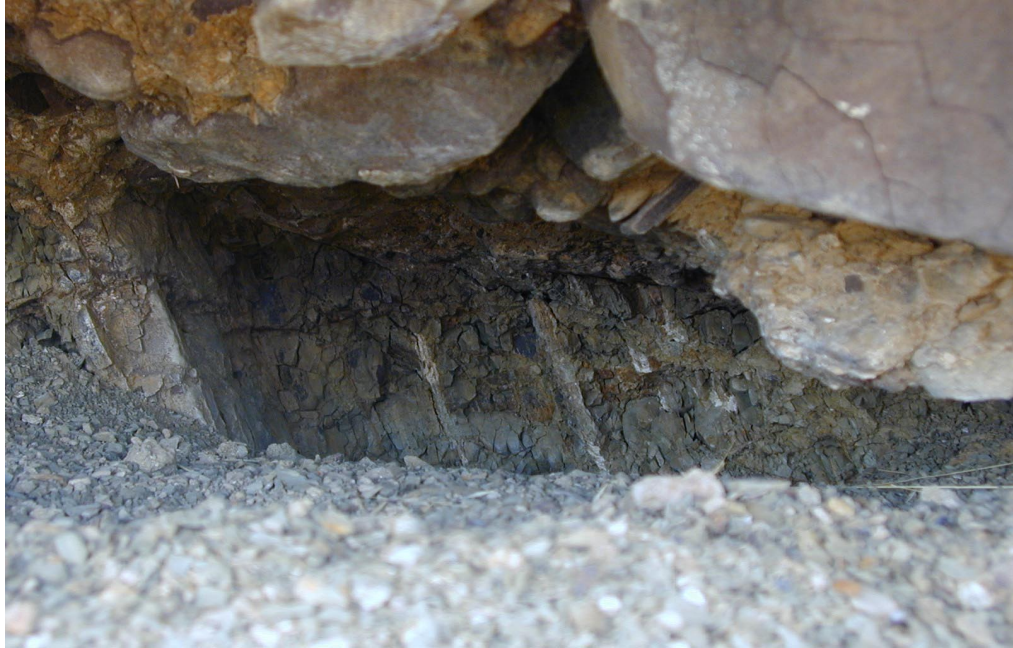
Photo 41. Contact between the Red Bluff and Boxer Formations (close-up)

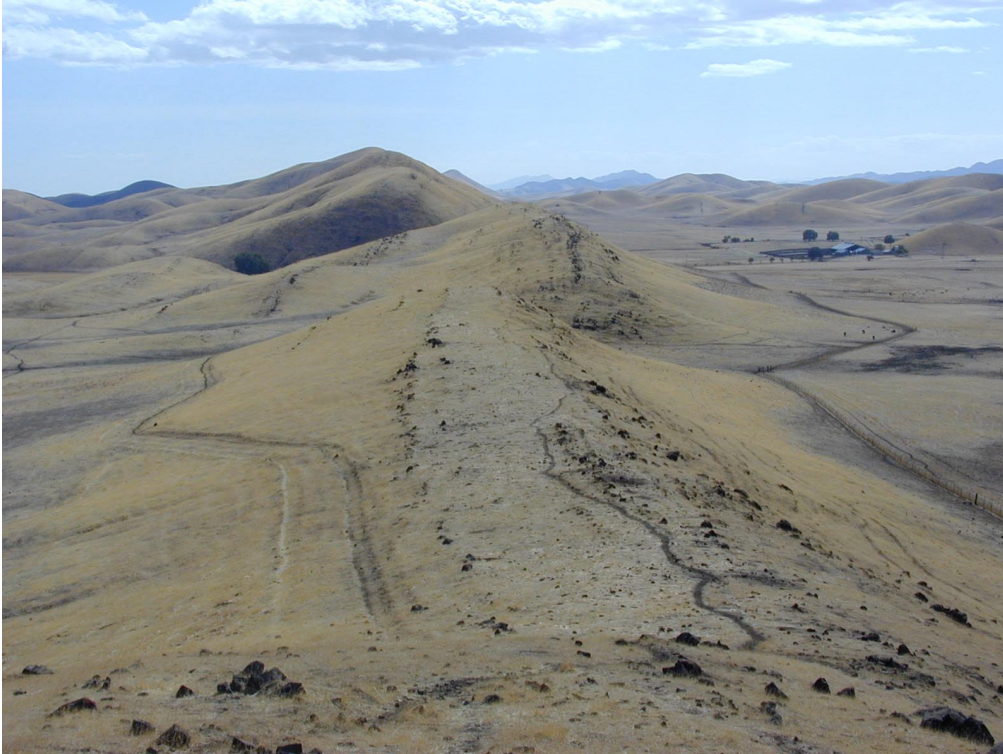
The northernmost lineament, L-1, crosses the dam alignment through a prominent windage approximately 3,600 feet north of Logan Creek and trends southwest to northeast (Photo 42). It is the most easily discernible lineament, with a definite shift in the rock units along the ridgeline. If this lineament is a fault, the sense of movement would be right lateral, with an apparent offset of 100 to 150 feet; and the fault plane would be near vertical. The lineament feature cannot be followed very far on either side of the ridgeline because of the sparsity of mappable sandstone units.

Photo 42. Lineament L-1 passing through the wind gap just above the center of the photo, with a noticeable shift in the ridge-forming sandstone.

- Run one seismic line east-west through the Logan Creek water gap to evaluate the depth to bedrock.
- Run two north-south seismic lines across Logan Creek both upstream and downstream of the water gap to evaluate how thick the terrace deposits are on the abutments.
- Run at least one northwest-southeast trending seismic line across the lineament on the left abutment to investigate possible fault evidence in the recent overburden.

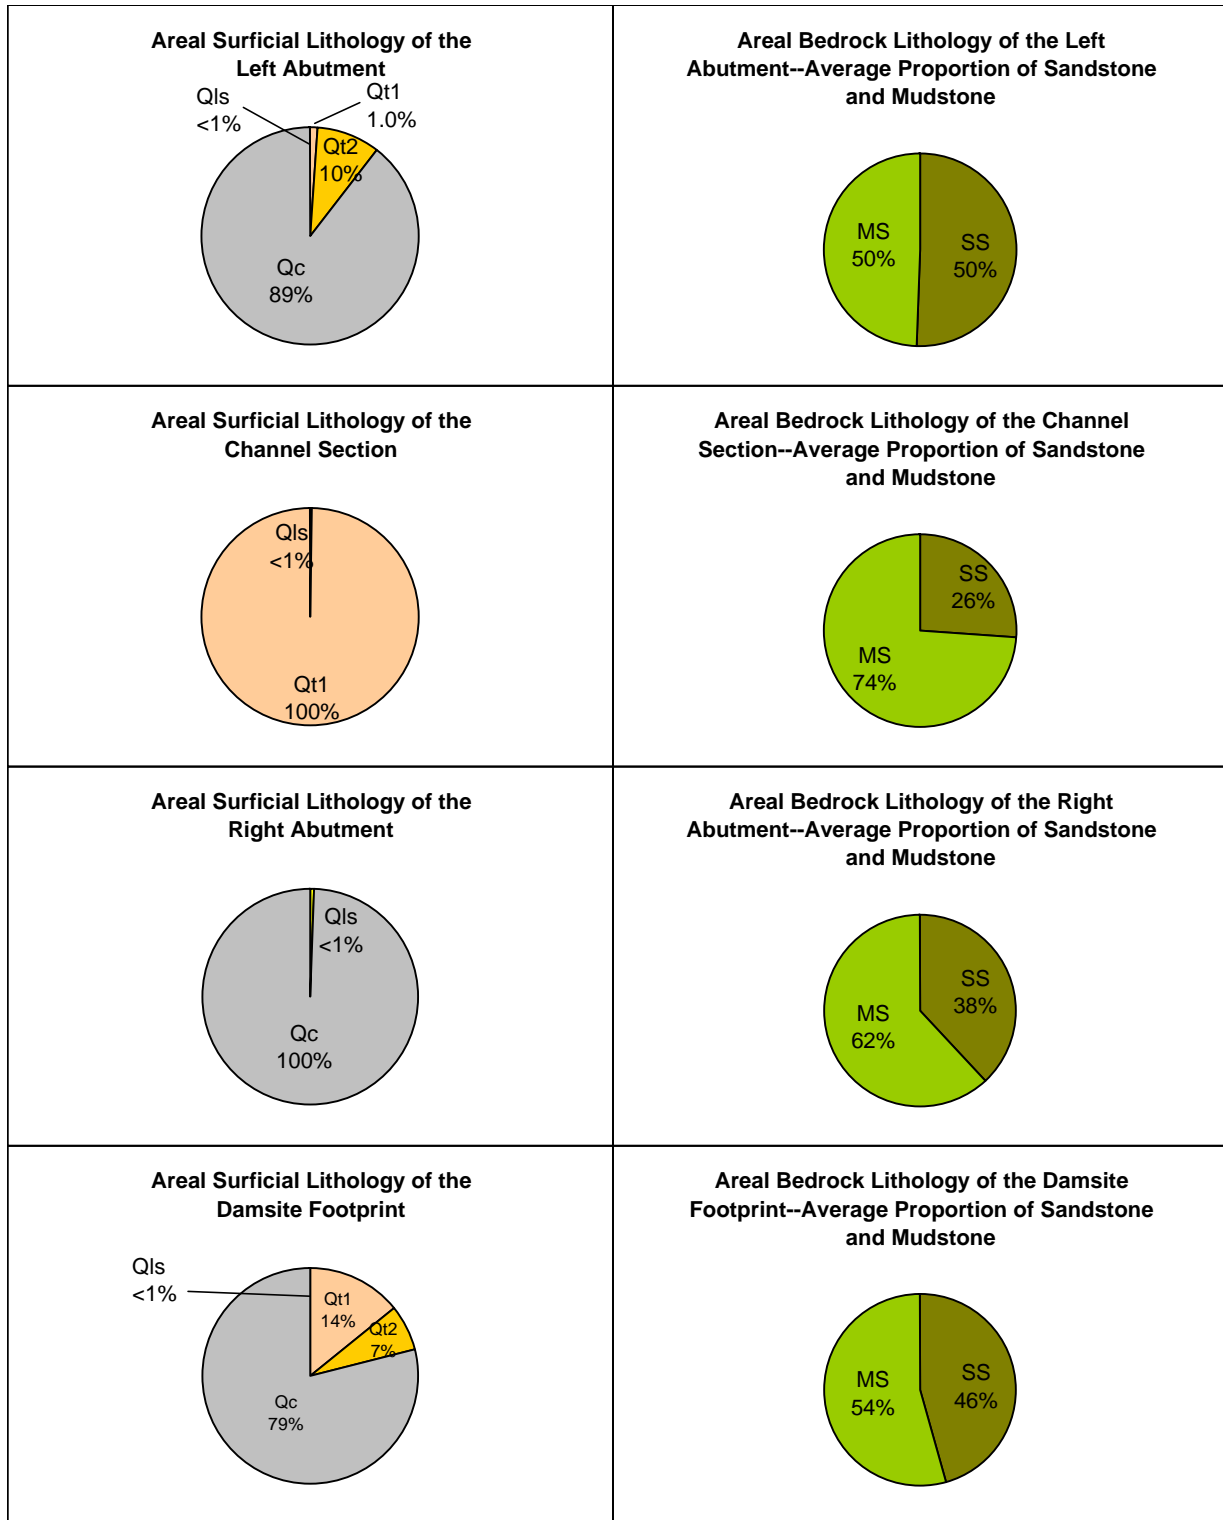
FIGURE 8: Colusa Reservoir Project, Logan Dam Site Surficial and Bedrock Lithology By Percentage

not been determined. Foundation conditions are summarized in Table 21, and the surficial geology is summarized in Figure 8.

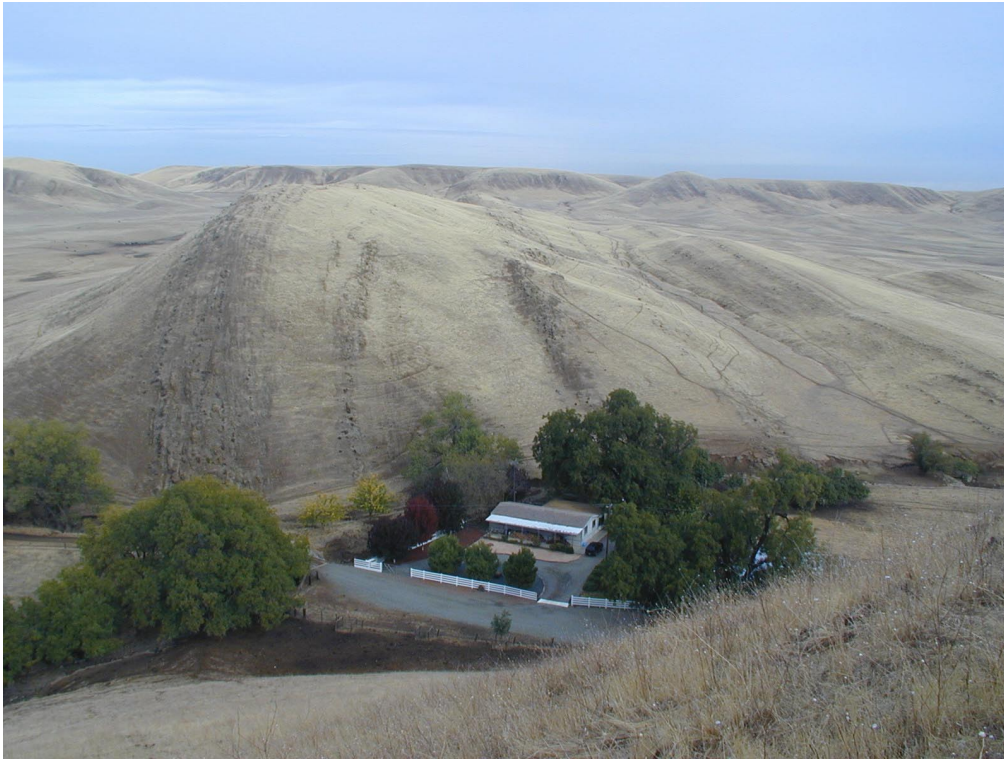
This abutment has a slope angle averaging 45 degrees on the western face of the main ridge and a gentler slope (25 degrees) on the eastern face. A secondary lower ridge, composed primarily of sandstone, extends parallel to the main ridge from Logan Creek channel approximately 2,500 feet north where it becomes more subdued as the sandstone bed pinches out (Photo 43). In addition, the western portion of the abutment extends approximately 600 feet out into the very gentle slopes of the Boxer Formation.

Stripping requirements may vary from a few feet in the more competent ridge-forming sandstones to 15 feet in the mudstones of the Boxer Formation. Stripping estimates are based only on visual surface observation because no subsurface exploration has been completed at this time.

Photo 43. Northern view of left abutment and channel of Logan Dam site

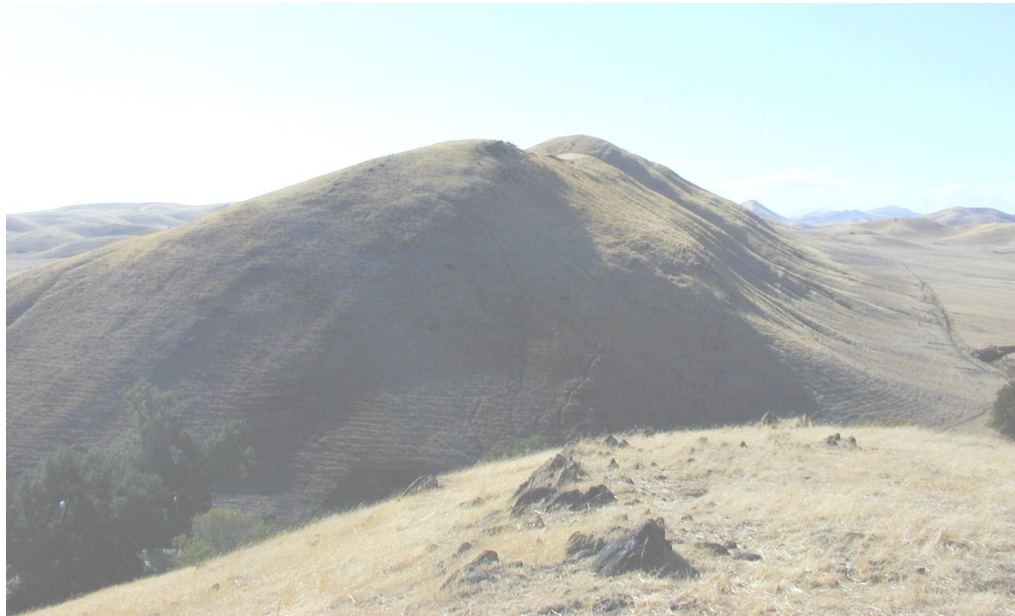
This abutment has a slope angle averaging 50 degrees on the western face of the ridge and a slightly gentler slope of 35 degrees on the eastern face (Photo 44). In addition, the western portion of the abutment extends about 600 feet out into the very gentle slopes of the Boxer Formation. Stripping requirements may vary from a few feet in the more competent ridge-forming sandstones to 15 feet in the mudstones. Stripping estimates are based only on visual surface observation since no subsurface exploration has been completed at this time. Vegetation on the right abutment consists exclusively of scattered grasses.

Photo 44. Southern view of right abutment of Logan Dam site

- Drill two diamond core drill holes along the Logan Creek water gap to determine depth to bedrock, rock type, and permeability.
- Drill one diamond core drill hole in the right abutment to determine rock type and permeability.
